Water Resources Management Plan

WATER RESOURCES MANAGEMENT PLAN

BANDELIER NATIONAL MONUMENT New Mexico

November 1999

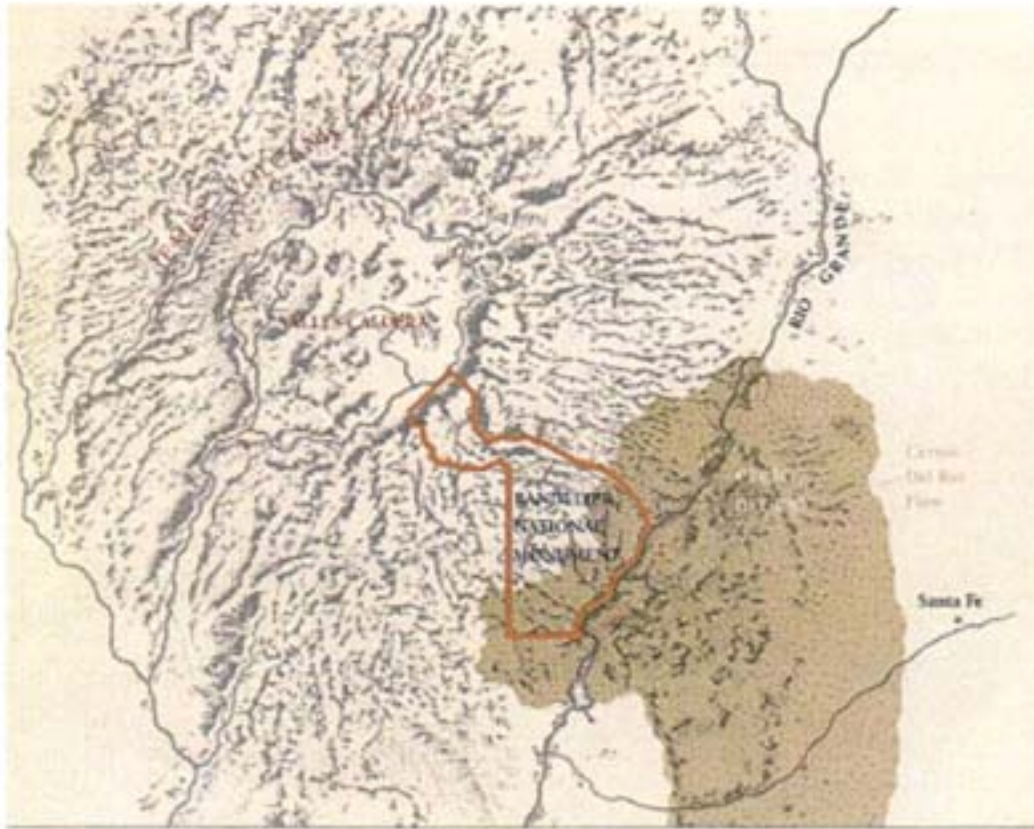
Figure 5. Physiography of the Valles Caldera Region (Barry, 1990).

Bandelier lies on the southeast flank of the Valles Caldera, the central feature of the Jemez Mountains (Figure 5). The Jemez Mountains are a complex volcanic pile at the intersection of two regional geologic features: the eastern rim of the Colorado Plateau to the west, and the Rio Grande rift to the east (Christensen, 1980). The Sierra de los Valles are the mountains encircling the caldera's rim. Streams draining the caldera form a radial drainage pattern (Figure 6). Drainage patterns at the scale of the Monument include: dendritic drainage pattern in headwaters; parallel drainage pattern across the Pajarito Plateau; and trellis drainage pattern within individual canyons (White and Wells, 1984).

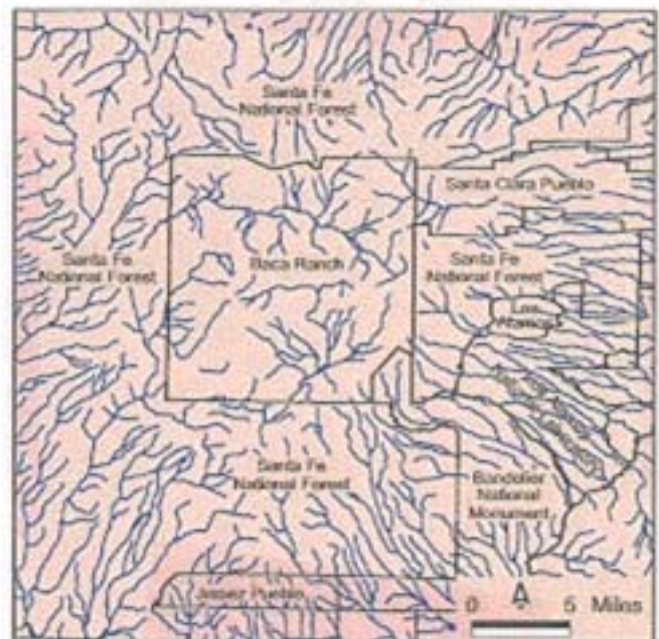
Figure 6. Radial Drainage Pattern Formed on the Valles Caldera (Source: BAND-GIS).

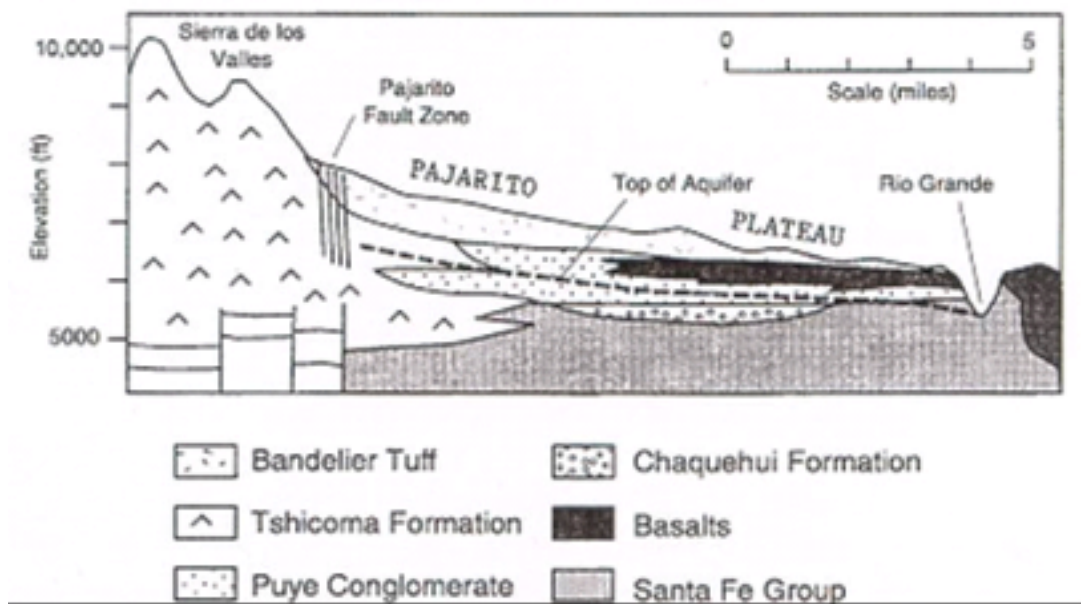
Figure 7. Cross-Section from the Jemez Mountains to White Rock Canyon (McLin et al., 1996).

The east flank of the Sierra de los Valles breaks to the gentler slope of the Pajarito Plateau, on which lies the majority of Bandelier (Figure 7). The Plateau is composed of gently sloping volcanic ash and lava flows and is terminated on the east by the deep canyon of the Rio Grande. The Pajarito Plateau has been dissected (in some places completely) by deep canyons. Between the canyons are elongated mesas, the surfaces of which share a common elevation and slope, and are remnants of the once continuous lava-flow. While the Bandelier country looks rugged and broken, most points have moderate slopes of less than 20 percent, with extremely steep slopes found on the near-vertical canyon and valley walls (Allen, 1989a). The San Miguel Mountains are an additional area of steep terrain (Figure 2) formed by an uplifted fault block of volcanic and sedimentary rocks lying southeast of the Valles Caldera.

Major faults along the western boundary of the Monument resulted from crustal adjustments associated with the Rio Grande rift (Purtymun and Adams, 1980). The series of normal faults shown in Figures 7 and 8 are part of the Pajarito fault system, a system of over 65 miles of mapped faults. This concentrated fault zone is 0.25 miles wide and has over 410 feet of displacement, with the down-dropped wall to the east (Los Alamos National Laboratory, 1998b). Seismic hazard studies indicate the Pajarito fault system could produce maximum earthquakes with a Richter magnitude of about seven. Although large uncertainties are inherent to such studies, Richter magnitude earthquakes greater than or equal to six were estimated to occur once every 4,000 years along the Pajarito fault zone. Other work indicates additional faulting underlying and pre-dating the Bandelier Tuff (U. S. Department of Energy, 1998).

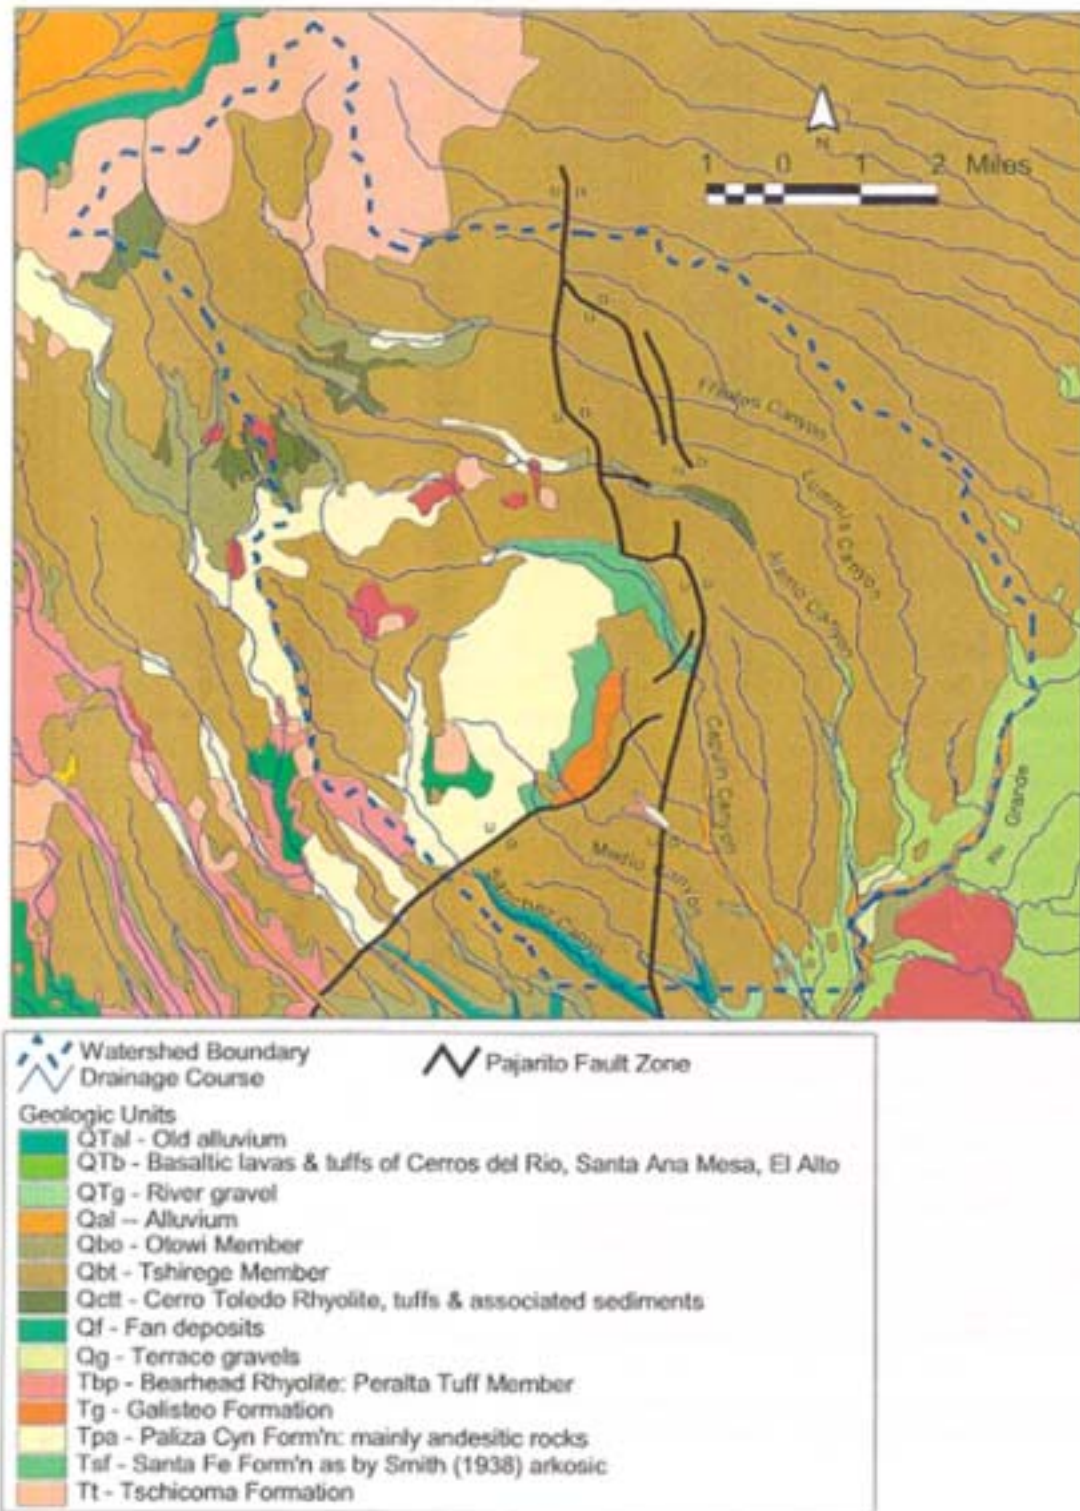
Figure 8. Surficial Geology at Bandelier National Monument. (Source: BAND-GIS)

Bandelier National Monument lies within an area of great crustal tension with a long history of volcanism; consequently, its surficial geology is predominantly volcanic extrusives (Figure 8). Sedimentary rocks are found on the east edge of the San Miguel Mountains and in the bottom of Capulin Canyon. Quaternary gravels (alluvium) occur in lower reaches of the canyons and along the Rio Grande River. East of the Rio Grande are a group of cinder cone vents forming the Cerros del Rio (Figure 5). These cones erupted 3 million years ago filling ancient valleys with basalt.

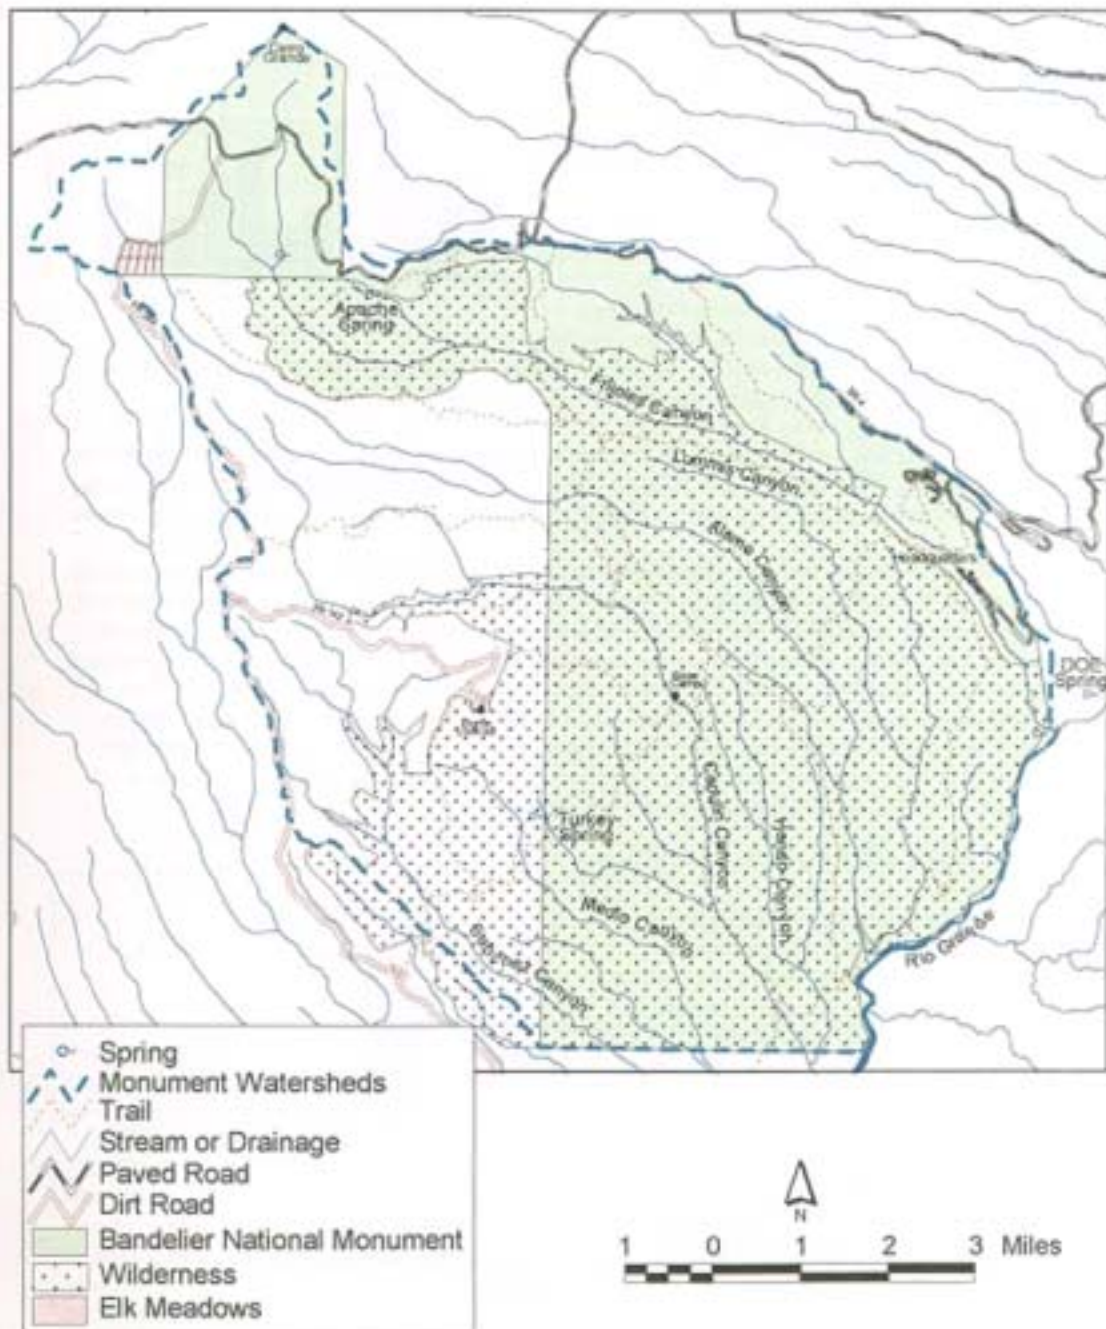
Figure 9. Surface Drainages and Springs at Bandelier National Monument.
(Source: BAND-GIS)

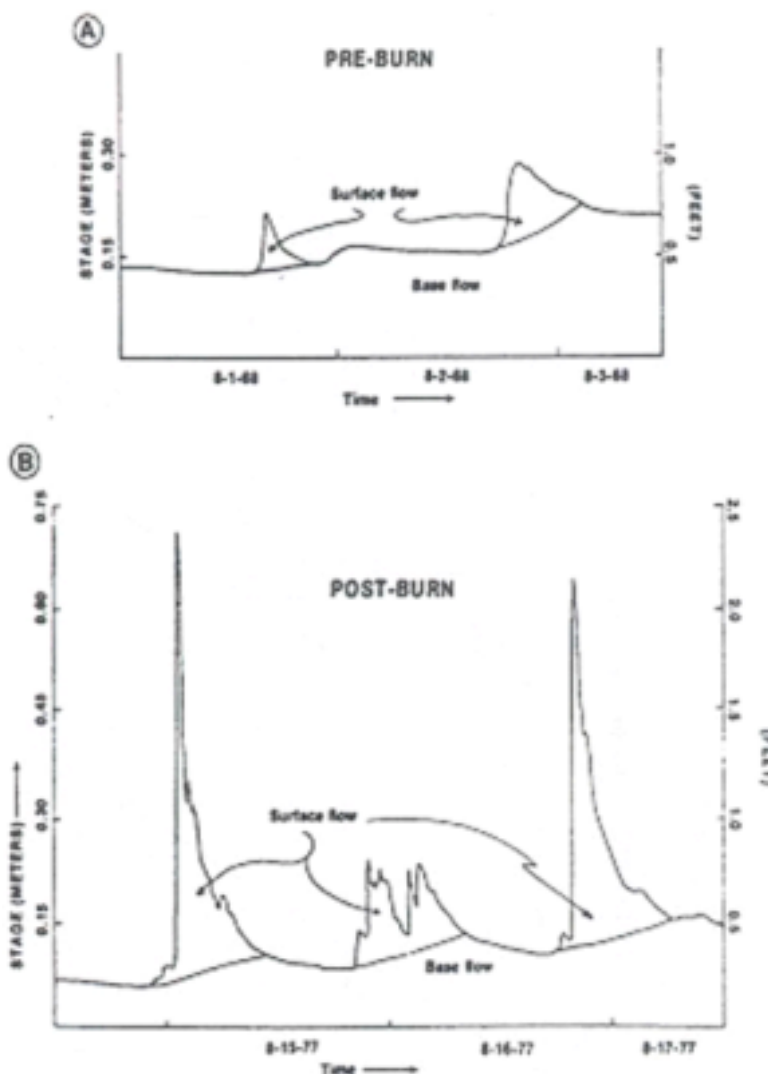
Figure 13. (a) Pre- and (b) post-La Mesa Fire hydrographs for Frijoles Creek (White and Wells, 1984).

Figure 13 indicates the post-burn hydrograph is flashier, with sharper, higher magnitude flood peaks, and steep limbs. The post-burn hydrograph illustrates a much larger surface component; whereas, the preburn hydrograph has a greater base-flow component. The variability of stream-flow can also be described by a flow-duration curve (Figure 14). The flow duration curve displays the frequency at which flows of various magnitudes are equaled or exceeded. Figure 14 indicates that 60 percent of the time the

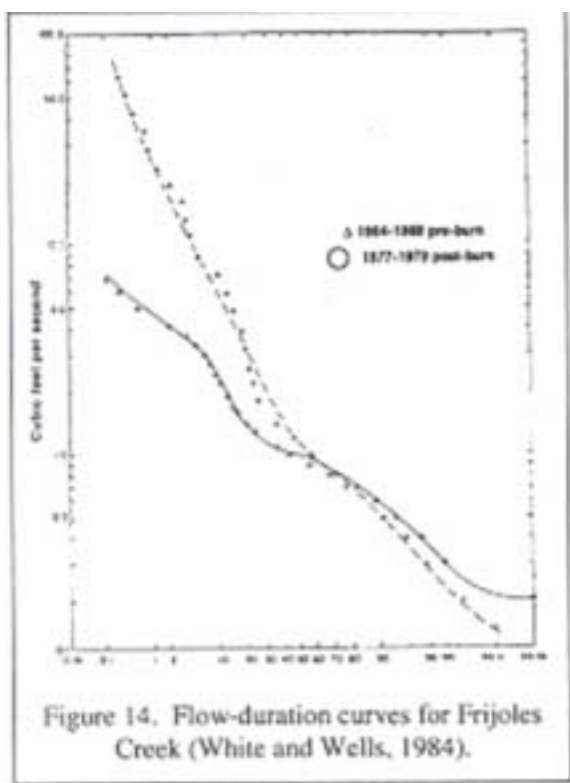
Figure 14. Flow-duration curves for Frijoles Creek (White and Wells, 1984).

post-burn discharge of Frijoles Creek is greater than the discharge of the same frequency for the pre-burn record. Furthermore, 10 percent of the time the flow of the post-burn record exceeds the 0.1 percent frequency event of the pre-burn record. Figure 14 also shows high-frequency base-flow events are smaller since the La Mesa fire (White and Wells, 1984).

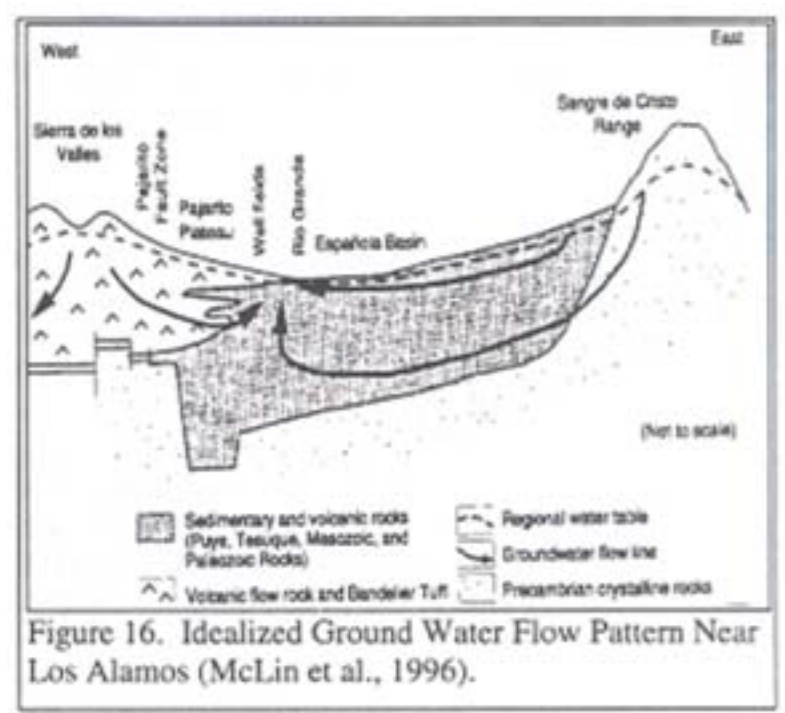
Figure 16. Idealized Ground Water Flow Pattern Near Los Alamos (McLin et al., 1996).

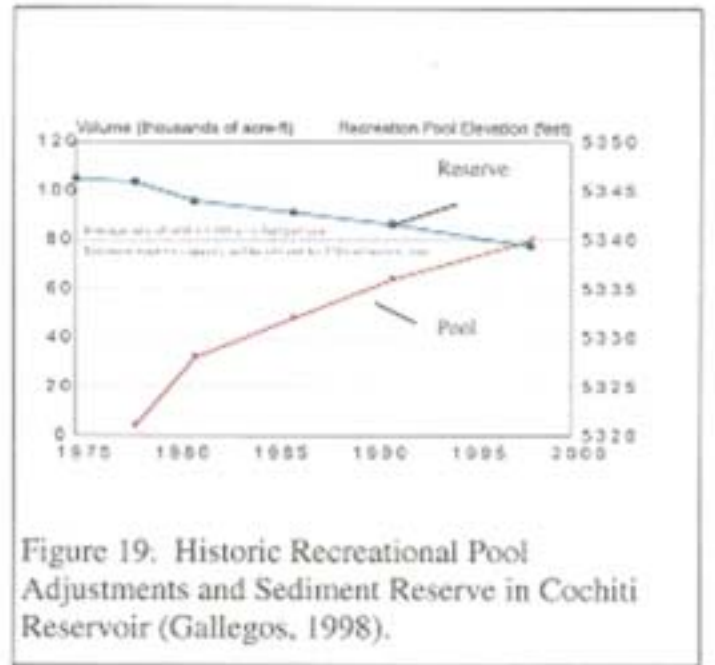
Figure 19. Historic Recreational Pool Adjustments and Sediment Reserve in Cochiti Reservoir (Gallegos, 1998).

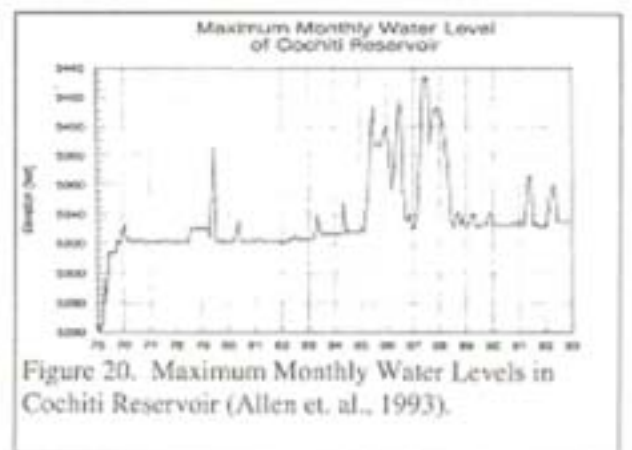
Figure 20. Maximum Monthly Water Levels in Cochiti Reservoir (Allen et al., 1993).

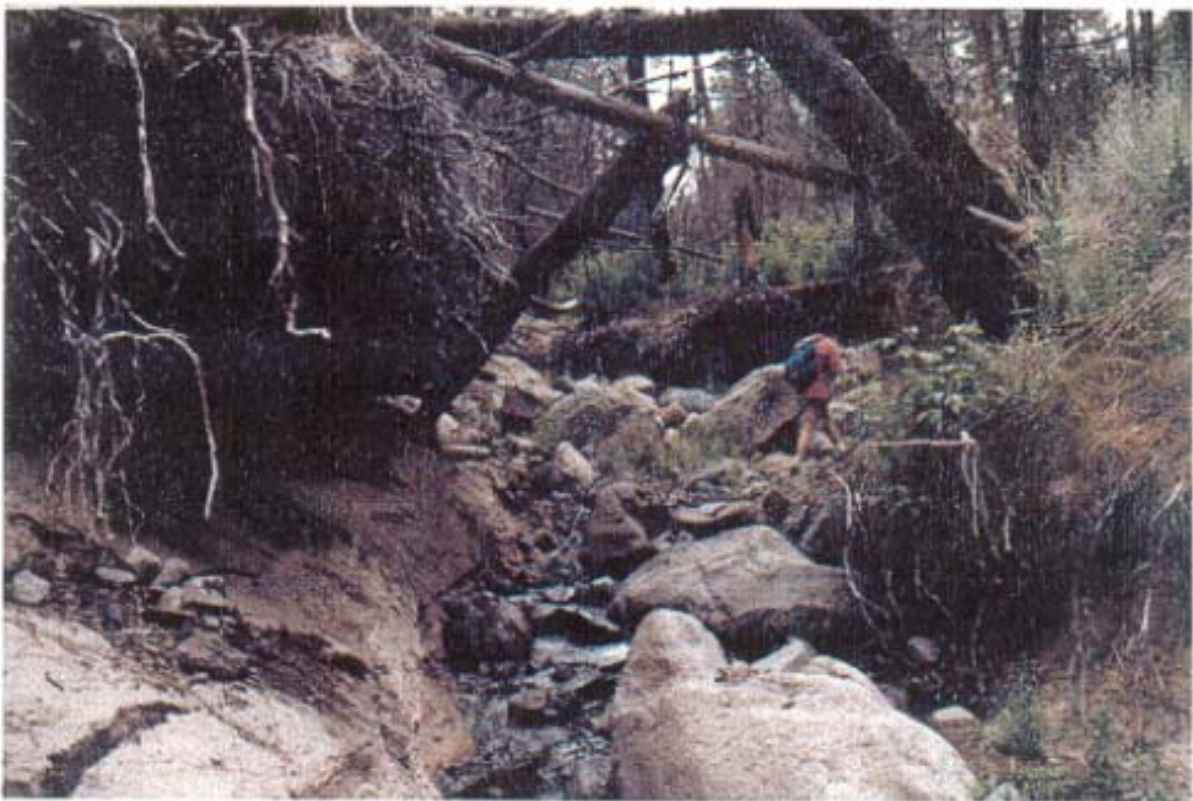
Photo 1. Stream Channel Incision within Capulin Canyon.

Even a casual observer can perceive the annihilation of habitat (i.e. pools, riffles, and runs) within Capulin Creek most obvious physical alteration is entrenchment which results in the stream channel being down-cut and widened so that subsequent flood flows are confined to a vertically walled trench and no longer spread out upon adjacent flood plains. The process of regaining a stable channel type is impeded by the inability of post-fire bank-full discharges to redistribute the available bedload and form a stable channel cross-section and new flood plain. Close scrutiny of geomorphic parameters in Frijoles reveals physical habitat alterations still exist in some of its reaches 20 years after the La Mesa Fire.

Another significant aspect of the incision was the removal of the cobble and boulder armor from the streambed and exposure and incision into the underlying friable sandstone. This easily erodible bedrock is visible in Photo 2 as the white strata rising about 6 feet above the level of the

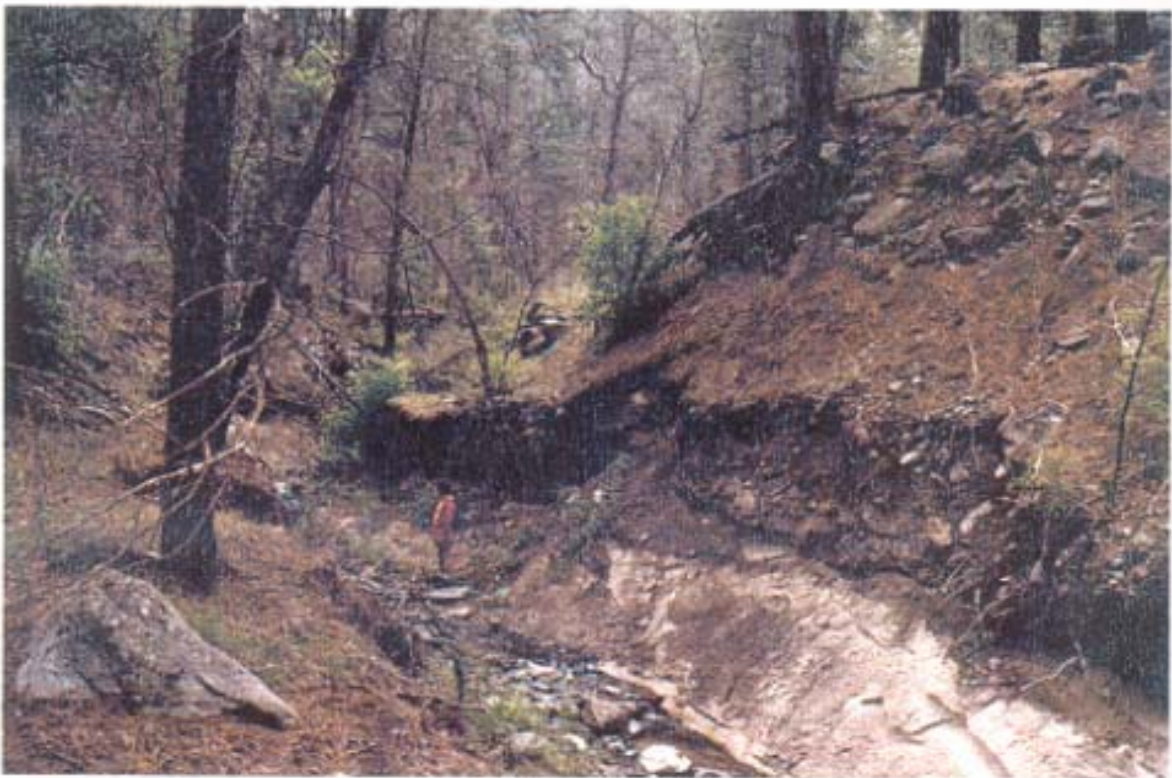
Photo 2. Channel Incision and Potential Slope Destabilization in Capulin Canyon.

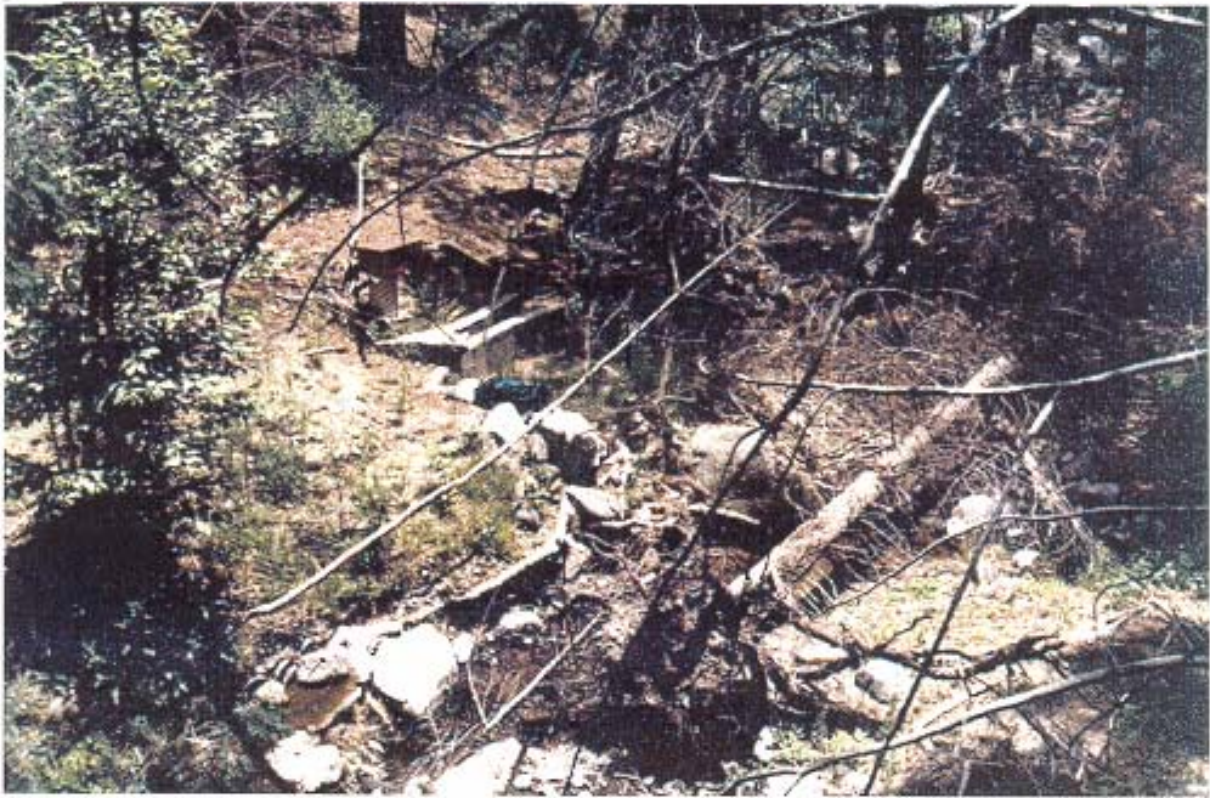
Photo 3. Peak-Flow Gauging Flume and Post-Flood Channel Within Capulin Canyon.

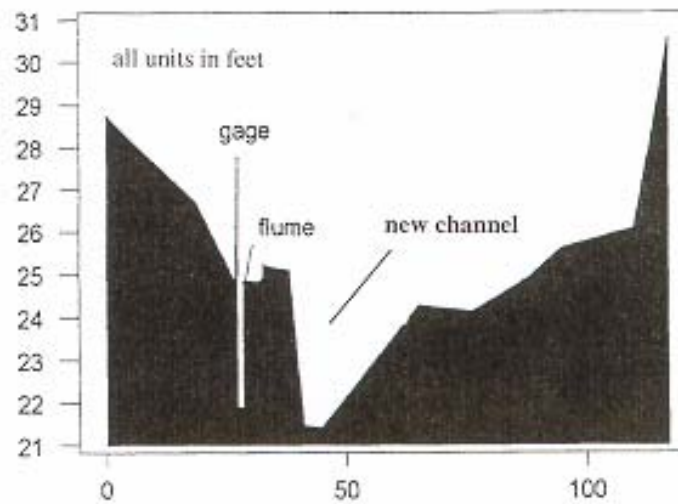
Figure 24. Post-Fire Cross-section of Capulin Creek at Old, Peak-Flow Gauge (Veenhuis, 1998).

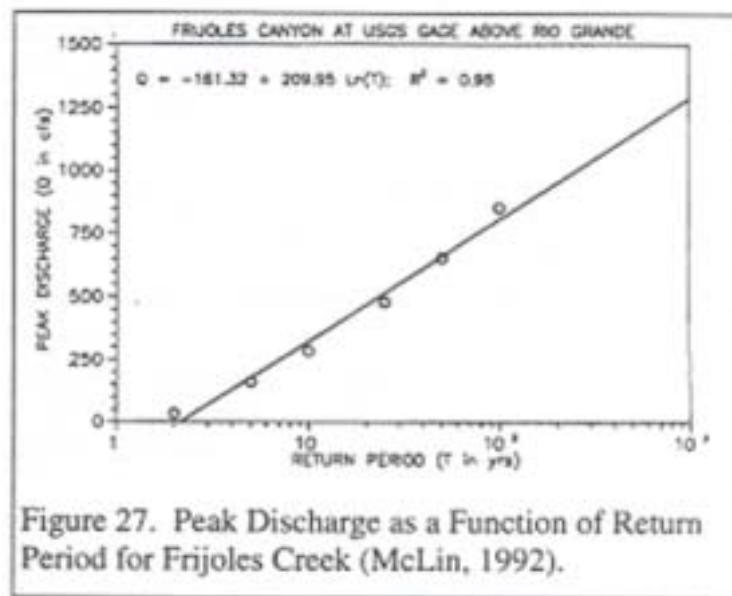
Taken from McLin's work is a graph of various return interval flows for Frijoles Creek at the USGS gauging station (Figure 27). Note that the 100-year flood has a peak calculated discharge of 853 cfs, significantly less than both the COE predicted 100-year flow of 2,750 cfs and the maximum post-fire observed flow of 3,030 cfs. Using McLin's graph and employing the equation for the best-fit line, a flood of 3,030 cfs would have a predicted recurrence interval in excess of 4 million-years. This is of note because McLin states "an observed. 100-yr 6-h storm has never been recorded at Los Alamos," yet according to his calculations, a 4-million year flow event has been observed.

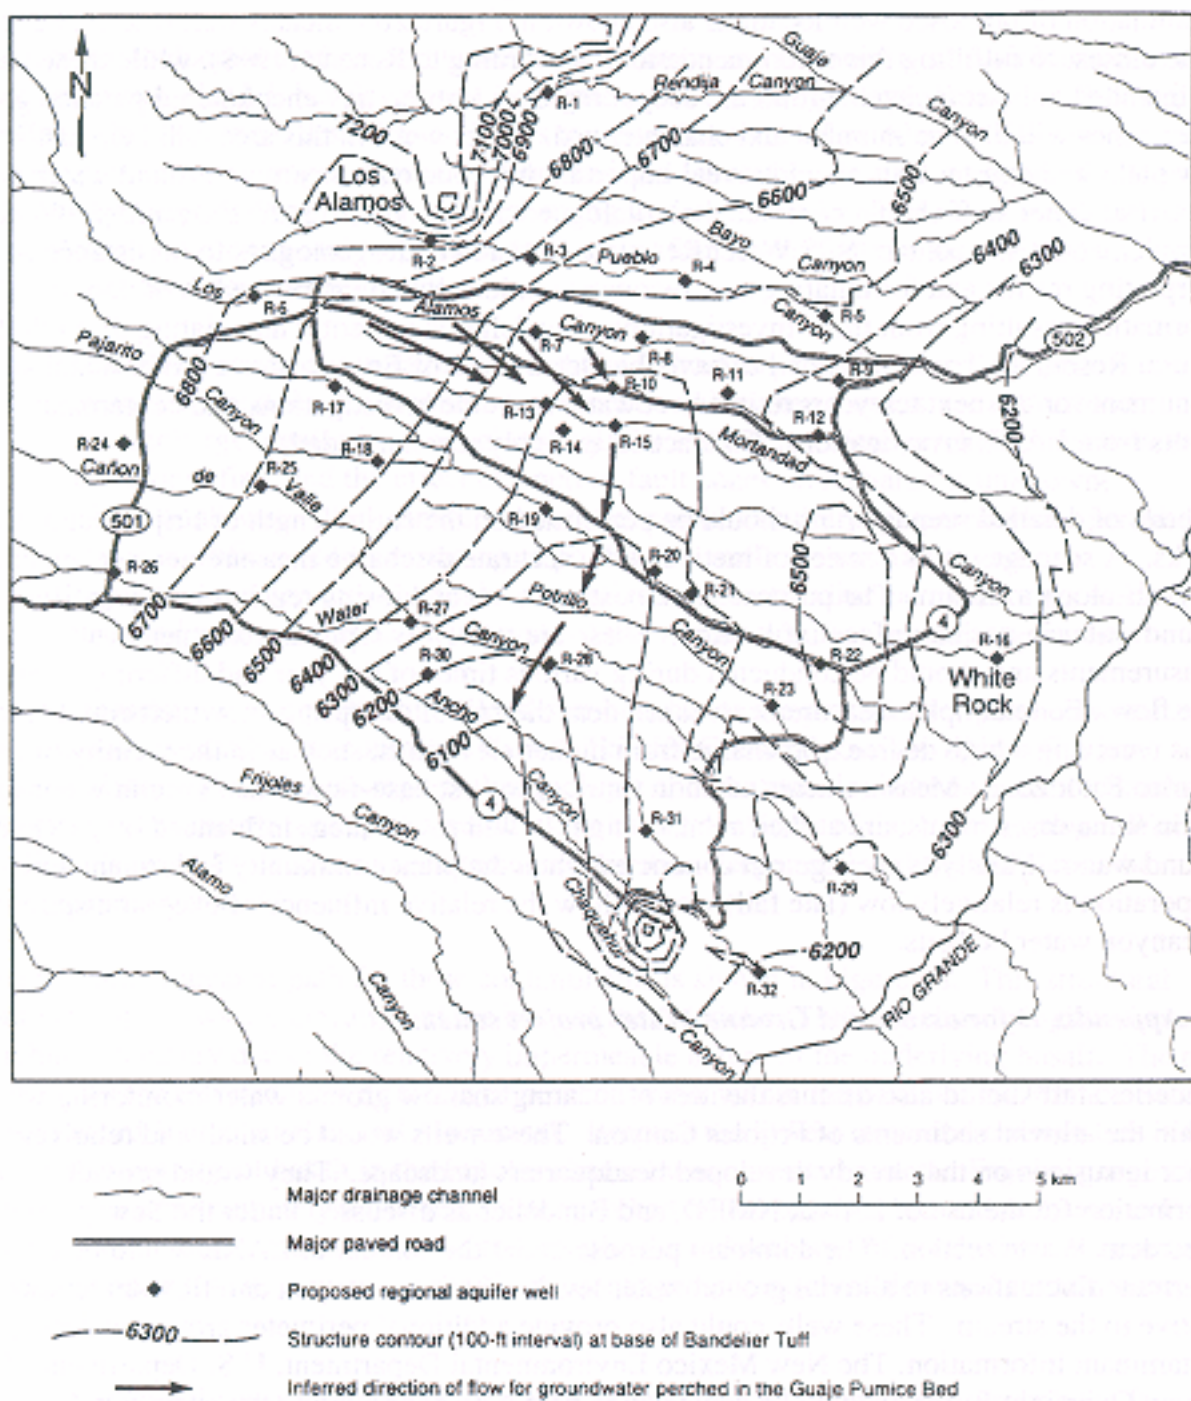
Figure 28. Inferred Direction of Perched Ground Water Flow Below Los Alamos National Laboratory and Locations of Proposed Regional Aquifer Monitoring Wells (LANL, 1998b).

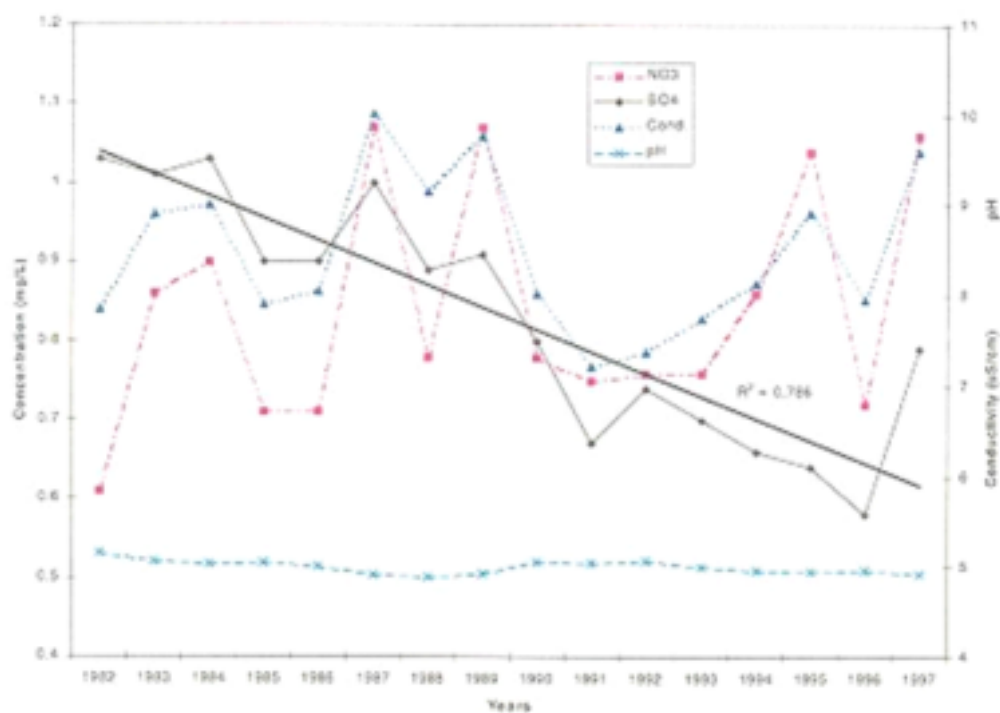
Figure 30. Bandelier National Monument Atmospheric Precipitation Yearly Averages with Trend Line Plotted for Sulfate (National Atmospheric Deposition Program Data).

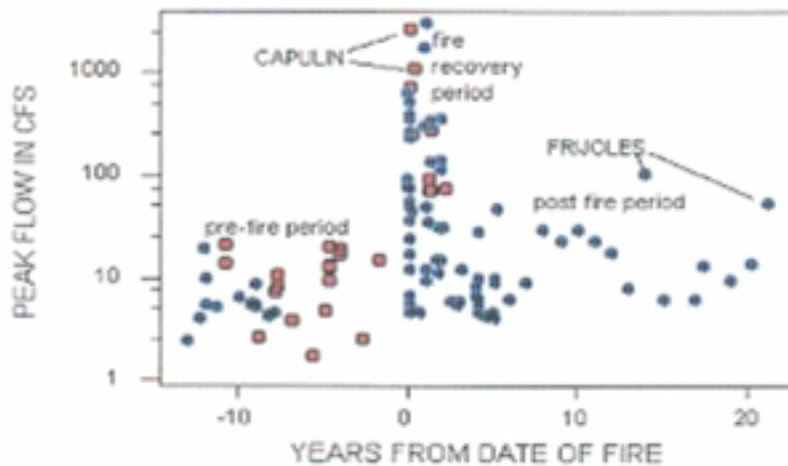
Figure 1. Peak flows in Frijoles and Capulin creeks before and after wildfires.

The runoff characteristics of both the Frijoles and the nearby Capulin basins changed radically as a result of the 1977 La Mesa Fire, and the 1996 Dome Fire, respectively. As displayed in Figure 1 (note y-axis is logarithmic), post-burn stream-flow records exhibit distinct changes in both

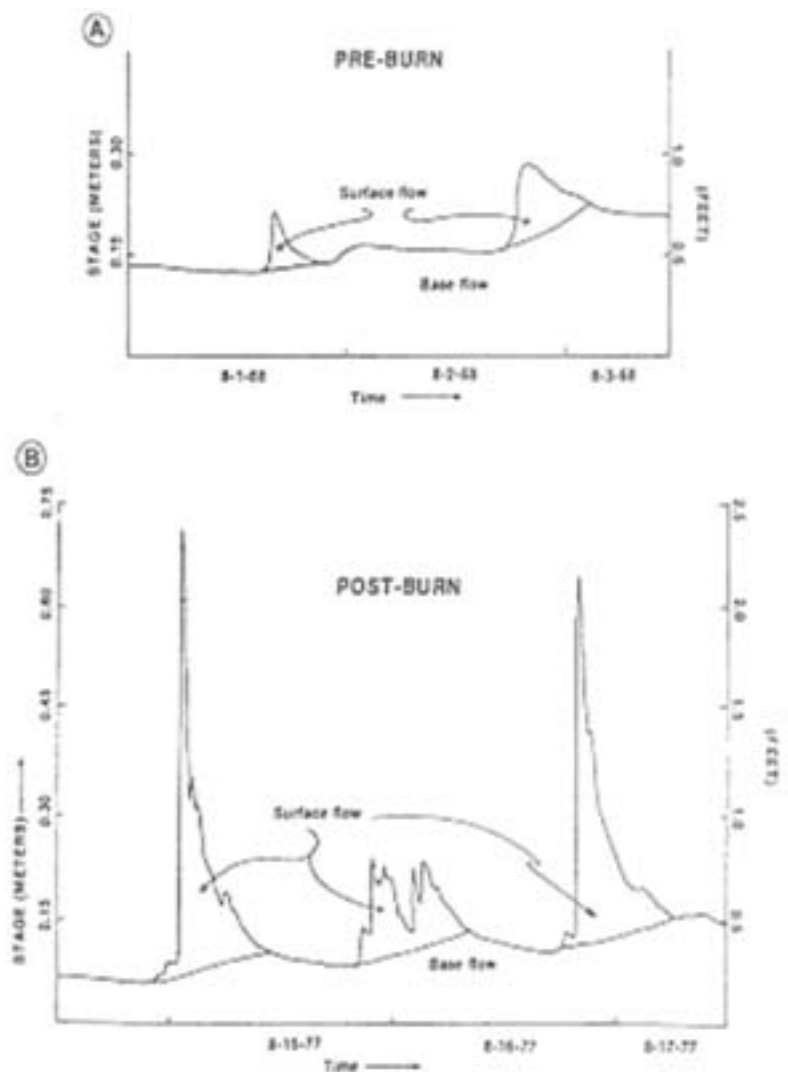
Figure 2. (a) Pre- and (b) post La Mesa Fire hydrographs for Frijoles Creek (White and Wells, 1984).

Purtymun and Adams (1980) analyzed pre- and post-La Mesa Fire streamflow records and determined "Runoff in 1978 was similar to years 1964-69. Though it appears that the volume of runoff has not changed, the time of collection and retention of precipitation in the drainage area has decreased. This resulted in larger discharge from runoff events." Figure 2 indicates the post-burn hydrograph is flashier, with sharper, higher magnitude flood peaks, and steep limbs. The post-burn hydrograph illustrates a much larger surface component; whereas, the pre

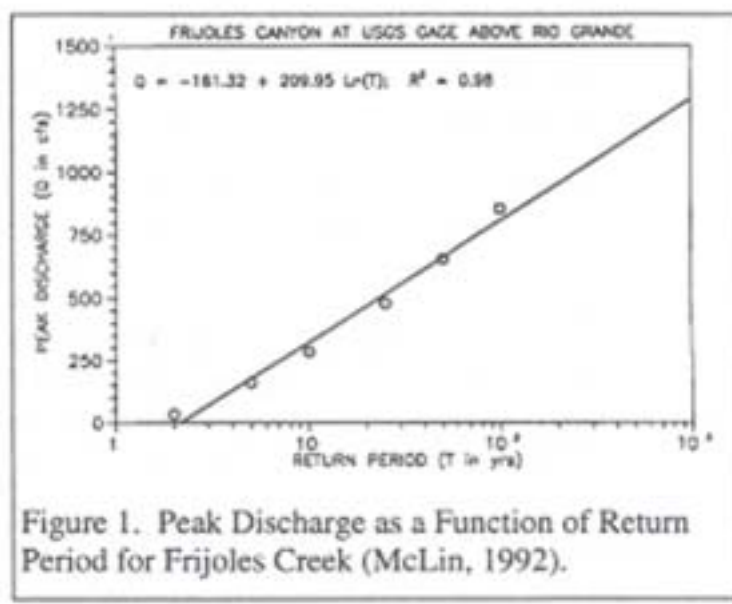
Taken from McLin's work is a graph of various return interval flows for Frijoles Creek at the USGS gauging station (Figure 1). Note that the 100-year flood has a peak calculated discharge of 853 cfs, significantly less than both the COE predicted 100-year flow of 2,750 cfs and the maximum post-fire observed flow of 3,030 cfs. Using McLin's graph and employing the equation for the best-fit line, a flood of 3,030 cfs would have a predicted recurrence interval in excess of 4 million-years. This is of note because McLin states "an observed 100-yr 6-h storm has never been recorded at Los Alamos," yet according to his calculations, a 4-million year flow event has been observed.

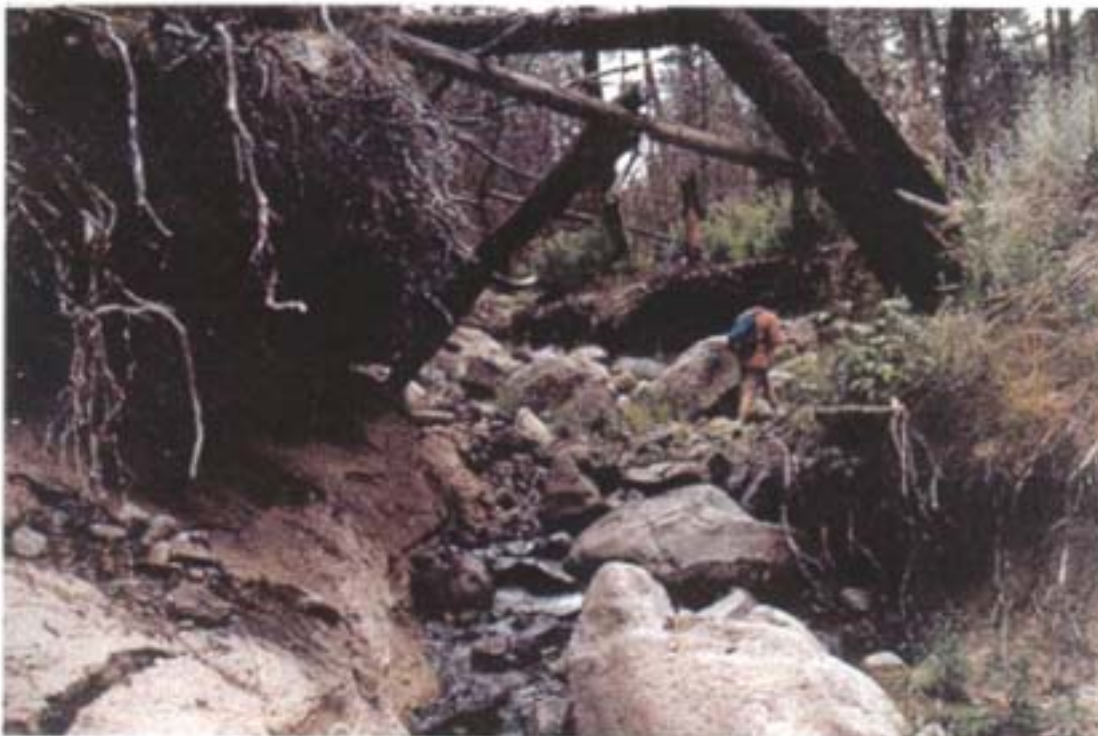
Photo 1. Stream Channel Incision within Capulin Canyon.

Even a casual observer can perceive the annihilation of habitat (i.e. pools, riffles, and runs) within Capulin Creek as a result of the floods triggered by the 1996 Dome Fire. The most obvious physical alteration is entrenchment which results in the stream channel being down-cut and widened so that subsequent flood flows are confined to a vertically walled trench and no longer spread out upon adjacent flood plains. The process of regaining a stable channel type is impeded by the inability of post-fire bank-full discharges to redistribute the available bedload and form a stable channel cross-section and new flood plain. Close scrutiny of geomorphic parameters in Frijoles reveals physical habitat alterations still exist in some of its reaches more than 20 years after the 1977 La Mesa Fire.

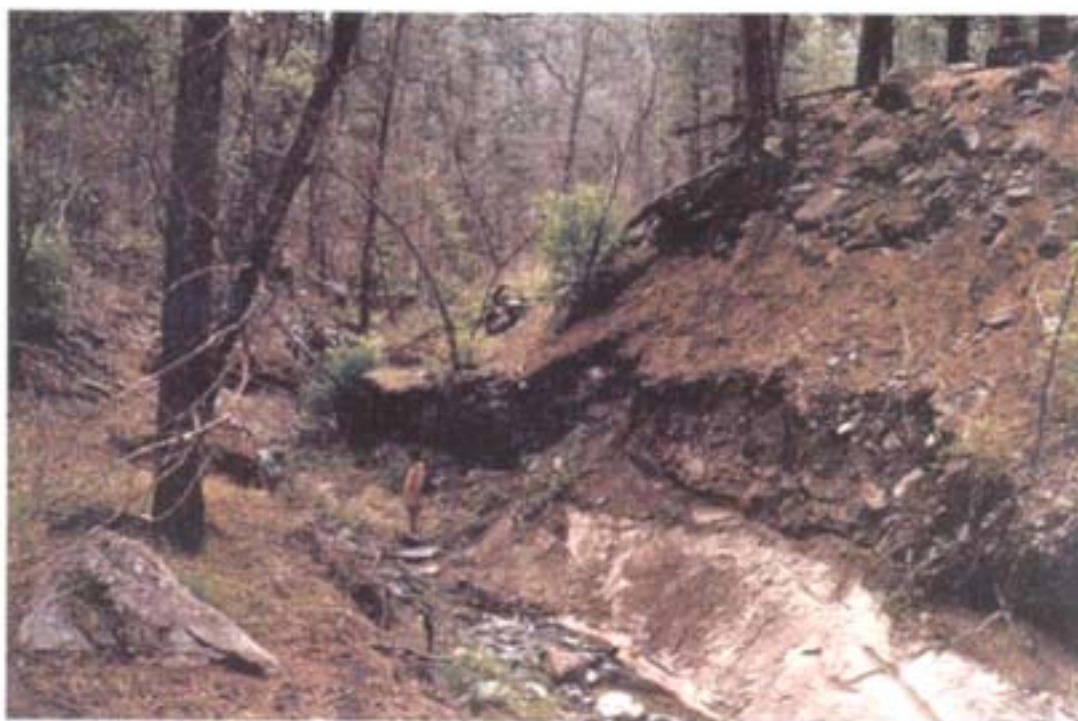
Photo 2. Channel Incision and Potential Slope Destabilization in Capulin Canyon.

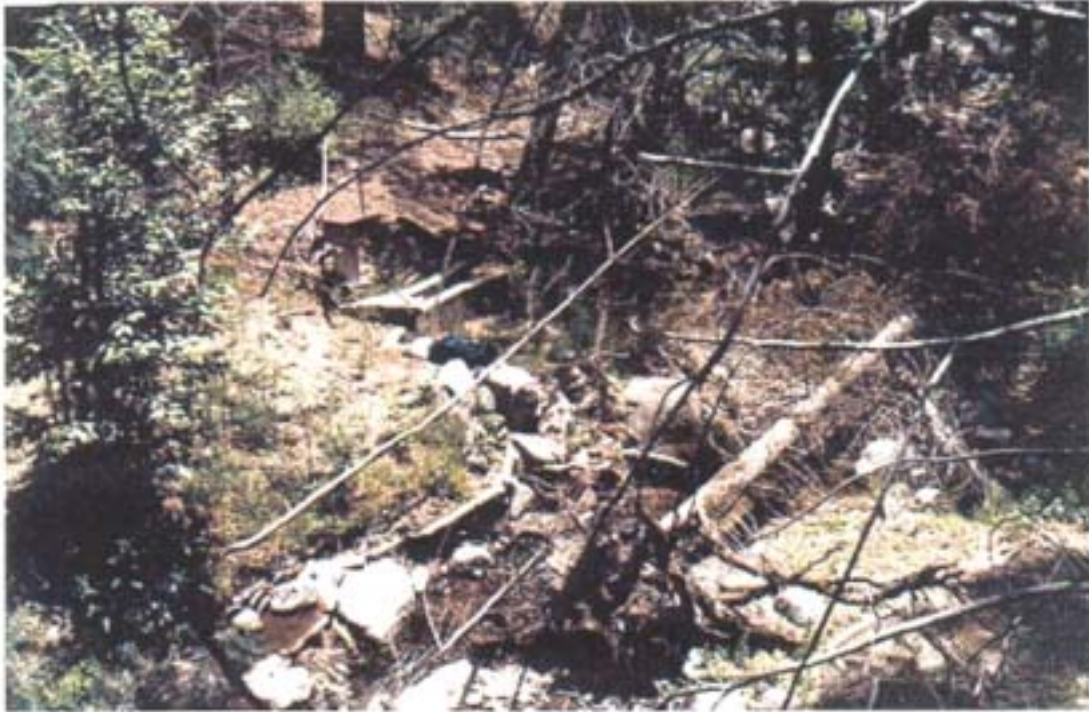
Photo 3. Old Peak-Flow Gauging Flume and Post-Flood Channel, Capulin Canyon.

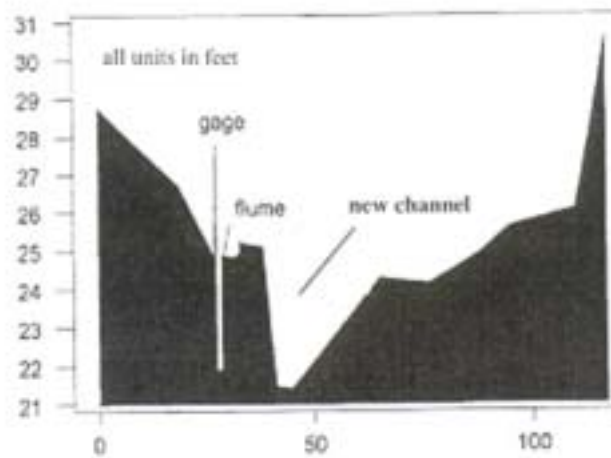
Figure 3. Post-Fire Cross-Section of Capulin Creek at Old Peak-Flow Gauge (Veenhuis, 1998).

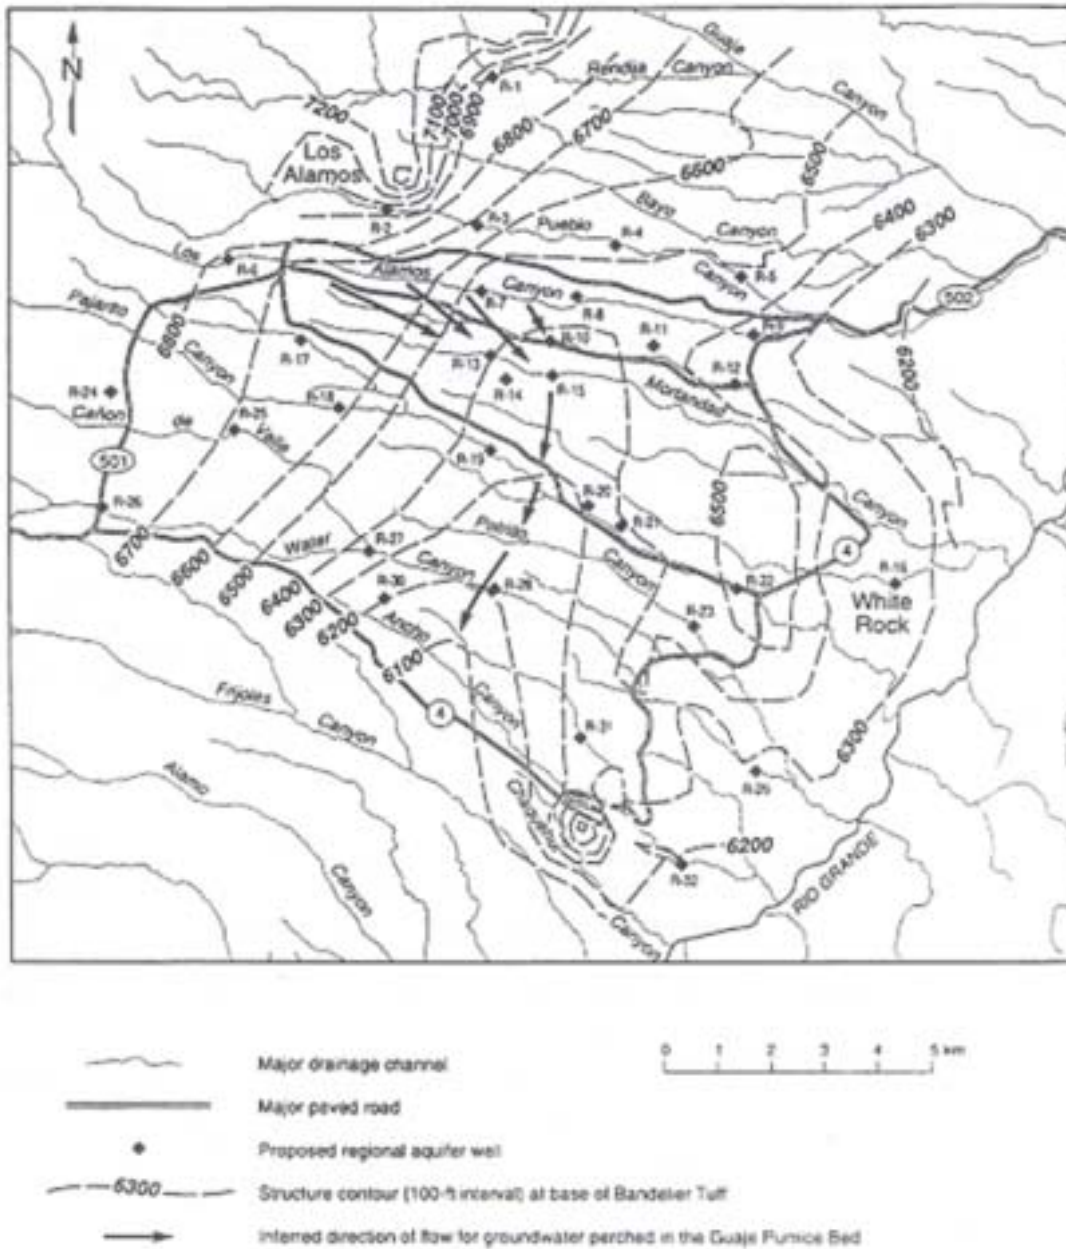
Figure 1. Inferred Direction of Perched Ground Water Flow Below Los Alamos National Laboratory and Locations of Proposed Regional Aquifer Monitoring Wells (LANL, 1998b).
